Navajo Abandoned Uranium Mine

Site Screen Report

Mine Name: **Henry Sloan No. 1**Mine IDs: **117, 118**

August 2011

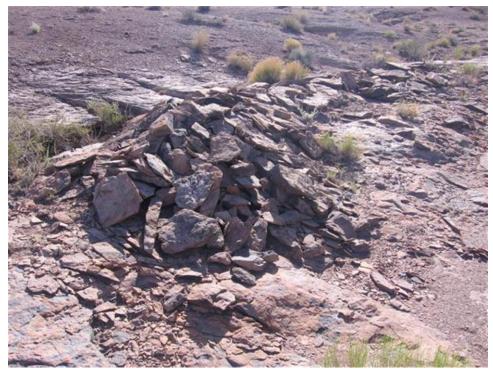
5 waste rock piles: Pile 1: 6' dia x 2' h, large rust-colored rocks; Pile 2 - 4' dia x 2' h, rust-colored rocks; Pile 3 - 5' dia x 2' h, large rust-colored rocks; 2 small waste rock piles in the NW portion of site

Photo 3: Mine Site #117; Waste pile 1

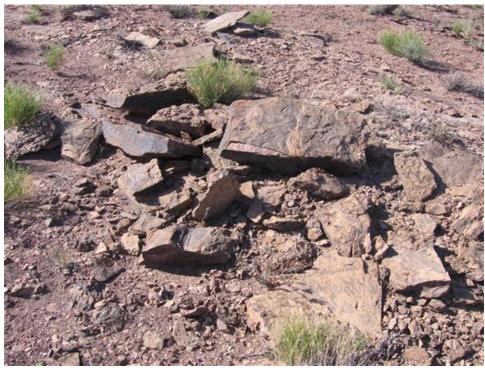
Photo 4: Mine Site #117; Waste pile 2

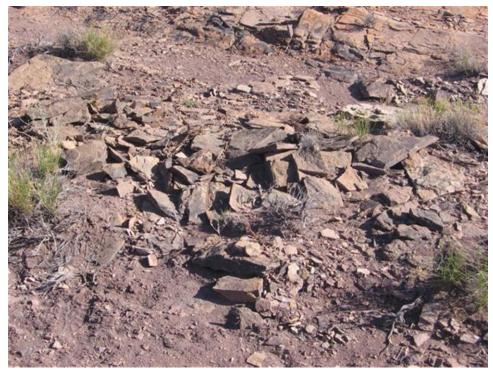
Photo 7: Mine Site #117; Waste pile 4

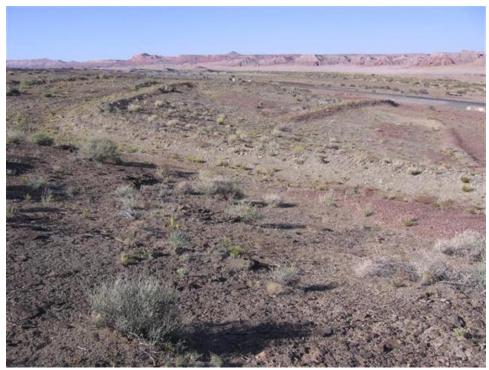
2 reclamation caps; Cap 1 - northern portion of site, erosion control berms, nearby tailings which might be waste debris used to prevent erosion; Cap 2 - southeast portion of site, erosion control berms, nearby tailings

Photo 9: Mine Site #118; Erosion control berms

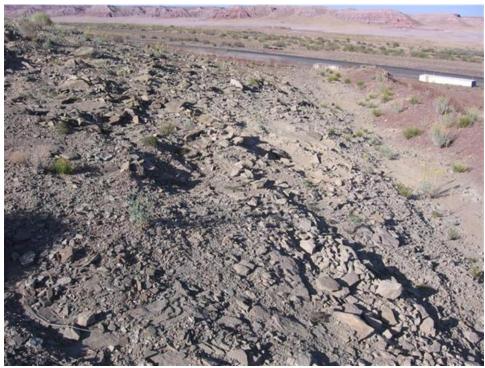
Photo 10: Mine Site #118; Tailings and Hwy 89

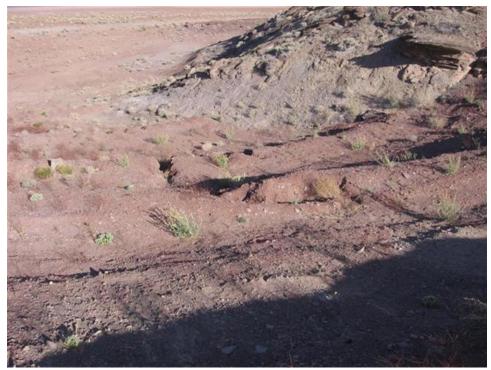
Photo 11: Mine Site #118; Compromised erosion control berms

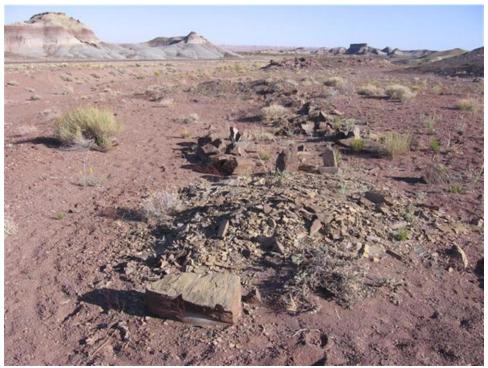
2 waste rock piles: Pile 1 - 8'x3'x2.5', beneath erosion control berms near road; Pile 2 - 4' dia x 1.5' h

Photo 12: Mine Site #118; Waste piles

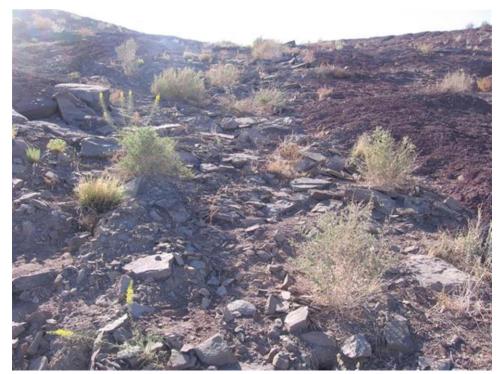
Photo 13: Mine Site #118; Tailings

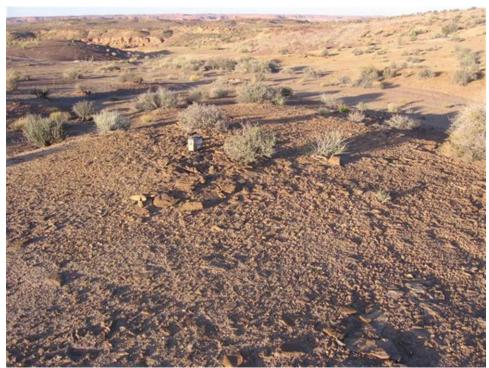
Photo 14: Mine Site #118; Debris from erosion control berms
